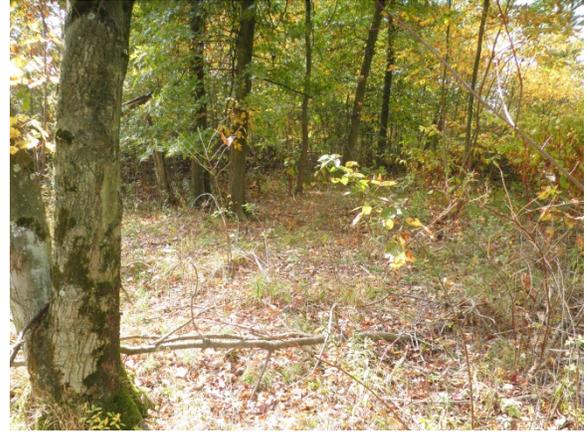
Sample Point CTX01a (Non-wetland)

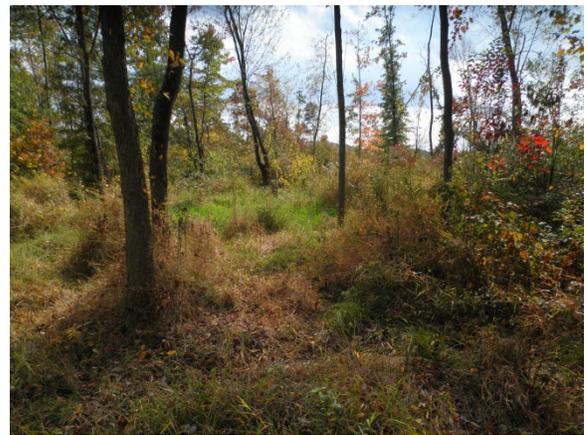
Sample Point CTX01b (Wetland)
