**TETLP OPEN PROJECT
STREAM SUMMARY**

SITE NUMBER A13-71-S1 RIVER BASIN Ohio River East DRAINAGE AREA (mi²) 0.05

**OPEN 30" Mainline Waterbody Photographs
Columbiana County, Ohio**

**Franklin Township MP 6.46
A13-71-S1**

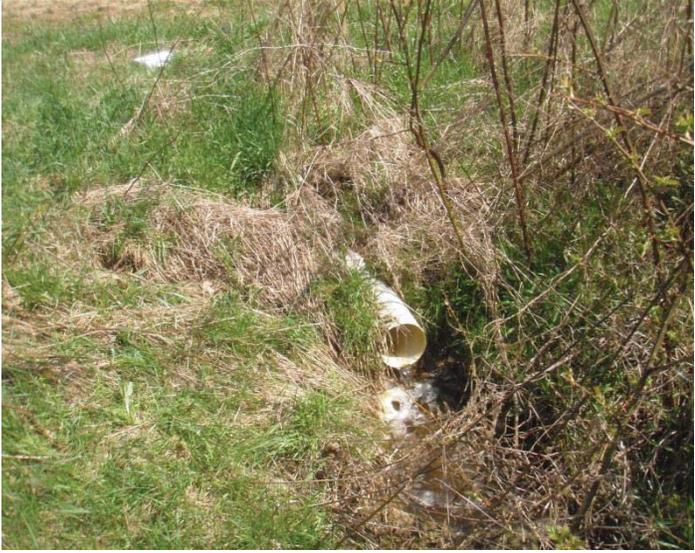
Photo 1: Intermittent stream, looking upstream to the north
Photo 2: Intermittent stream, looking downstream to the south
